Material evidence

Simulations have helped understanding of the performance of cob walls during flooding, as **Alan Foster**, **Gabriella Medero** and **Tom Morton** explain

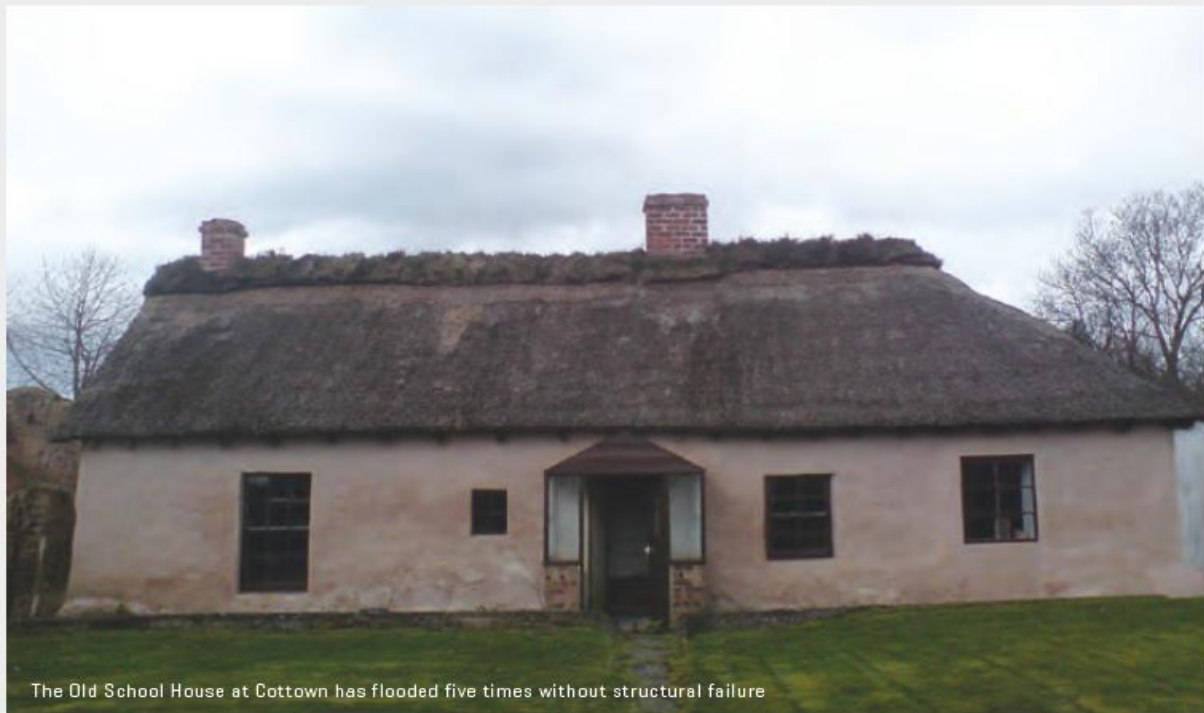
Take the example of the Old School House at Cottown, Perthshire, built around 1760 of cob – one of the most frequently occurring types of earth construction. The building had been flooded five times in recent years, but while the submerged regions exhibited undercutting and loss of earth materials from the wall faces, there was no structural failure. In a bid to gather data, a study was carried out at Heriot-Watt University that

The Old School House at Cottown has flooded five times without structural failure

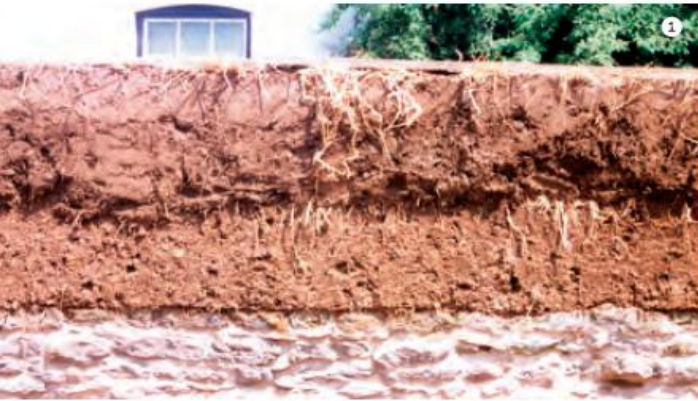
Cob construction relies on a suitable base made of rubble stone work built in lime mortar, on which are placed suitably prepared earth materials. Balancing the amount of clays and aggregates is essential for most types of earth building, and the clay component can vary from 10% to 40%. Additionally, straw is an essential component, increasing the tensile strength and reducing cracking. The cob material is generally lifted in place using a pitch fork, and built up in non-shuttered (unconfined) working lifts 500mm in height. Compaction is achieved by the operative's feet pressing the wall head then the use of a wooden plank dropped onto the surface, creating a level plane for the next lift. The sides are then 'pared', cut to a relatively perpendicular plane, before final consolidation using a 'mud hammer'.

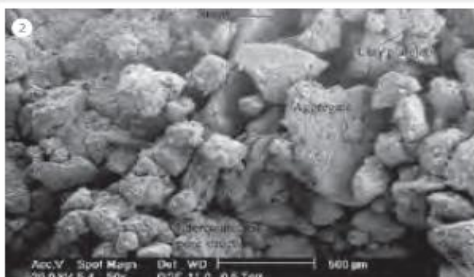
better. The sample at 500 μm (see [photo 2](#)) has a relatively open textured appearance with an interconnected pore structure over a large order of magnitude. The pore size distribution ranges from several mm through to approximately 200 μm .

The angular aggregate can clearly be seen with a range of particles sizes and distribution. Clay platelet agglomerations are adhered to the surface of the grains, ranging from several mm through to approximately 100 μm . Straw reinforcing can be seen within the centre of the image and appears fibrous in nature. Clay is adhered across its surface.

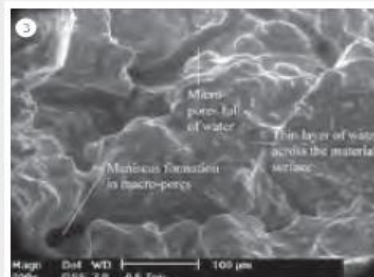
[Photo 3](#) illustrates a thin layer of water that has coated the sample. The development of menisci between the clay/aggregate particles can be seen in several locations. The micro-pore structure is apparently full of water, while the macro-pores are still unsaturated. The clay particles and siliceous aggregates are hydrophilic in nature.
